**Flood Control Project Maintenance
Levee Inspections**

Fall 2018 Levee Maintenance Deficiency Summary Report

Sacramento River Basin

**Flood Control Project Maintenance
Levee Inspections****LMA District Cover Sheet****Fall 2018 Levee Inspection Results****Sutter Maintenance Yard Maintenance Area 0013**

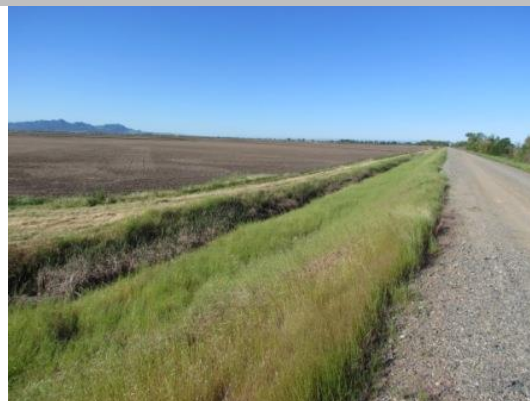
Photo 1 of 1 : FA_2018_MA0013_301_21_20180905_00009.jpg

LM Start	19.37	Rating **	M	Issue No.	21
LM End	19.92	Issue Type +	En	Location *	LS
Category	Earthen Levee			GPS Latitude/Longitude	
				Start	End
Item	Encroachments			39.383252 °	39.378192 °
				-121.830565 °	-121.838543 °
DWR ID	DWR_MA0013_02_s_2012_21				
Comment Code					
DT : Ditch					
Inspector Comment

View of the agricultural ditch along the toe.

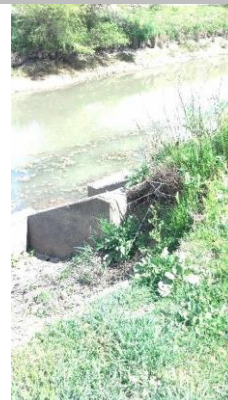
Photo 1 of 3 : UCIP_FA_2018_52164_67401.jpg

FS_ID:52164
DS_ID:16375
EP_NO: N/A
Repair Type: Non-Urgent
Crossing Status: Found
UCIP Comments: 5/30/2017 Erosion still present at WS headwall. Pipe has been selected to be internally cleaned and inspected as part of the DMP project. (DWR Sutter Yard- A Freitag)11/17/2016 Erosion still present at WS headwall. (DWR Sutter Yard- A Freitag)4/26/2016 Erosion still present behind the WS headwall. The rest of the crossing appears in good condition.6/30/2015 Erosion still present behind the WS headwall. Everything thing else with the crossing appeared to be in good condition.12/4/2013 Same as last inspection.5/28/2014 Same as last inspection.7/08/2013 Erosion problem same as last inspection. WS and LS slopes have been cleared of vegetation and are in good shape.4/24/2012 Erosion present behind WS headwall. Limited inspection on WS and LS slopes due to dense vegetation. Need photos of cleared WS and LS slopes during next inspection.

Erosion behind WS headwall looking at the downstream edge of headwall.

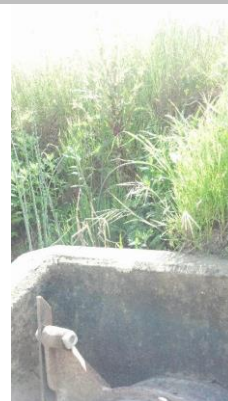
Photo 2 of 3 : UCIP_FA_2018_52164_67400.jpg

Erosion behind WS headwall at the upstream edge of headwall.

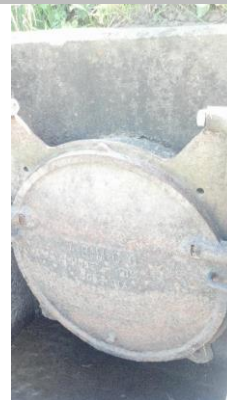
Photo 3 of 3 : UCIP_FA_2018_52164_67402.jpg

Flap gate located on the WS.

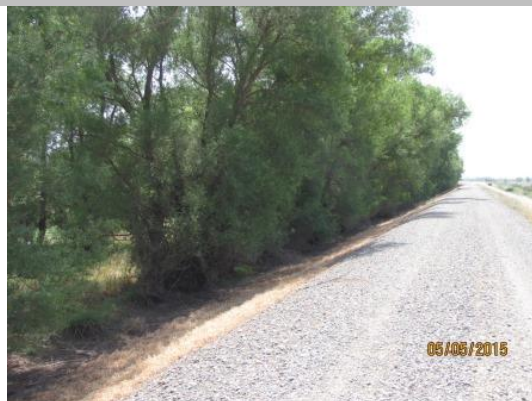
Photo 1 of 1 : FA_2018_MA0013_301_6_20180905_00002.jpg

LM Start	20.43	Rating **	M	Issue No.	6
LM End	20.74	Issue Type +	Ma	Location *	LS
Category	Earthen Levee			GPS Latitude/Longitude	
				Start	End
Item	Trim / Thin Trees			39.373091°	39.370795°
				-121.845225°	-121.850124°
DWR ID	DWR_MA0013_02_s_2013_6				
Comment Code					
T1 : Trim trees to at least five feet above ground level.					
Inspector Comment

View of the overgrown trees along the landside slope.

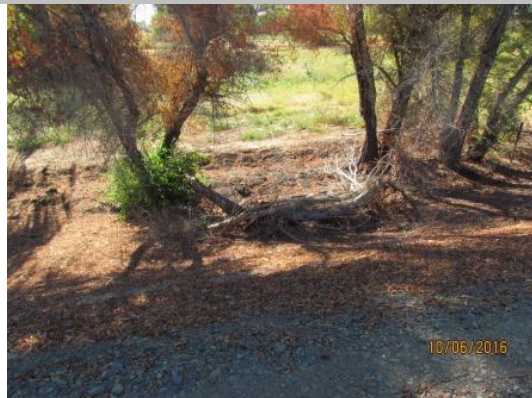
Photo 1 of 1 : FA_2018_MA0013_301_73_20180905_00021.jpg

LM Start	20.52	Rating **	M	Issue No.	73
LM End	20.52	Issue Type +	Ma	Location *	LS
Category	Earthen Levee			GPS Latitude/Longitude	
				Start	End
Item	Encroachments			39.372486 °	39.372486 °
				-121.846537 °	-121.846537 °
DWR ID	DWR_MA0013_02_f_2016_73				
Comment Code					
TR : Tree or limb					
Inspector Comment					
Remove the tree limbs from the landside slope and toe.

View of the tree limbs along the landside levee toe.

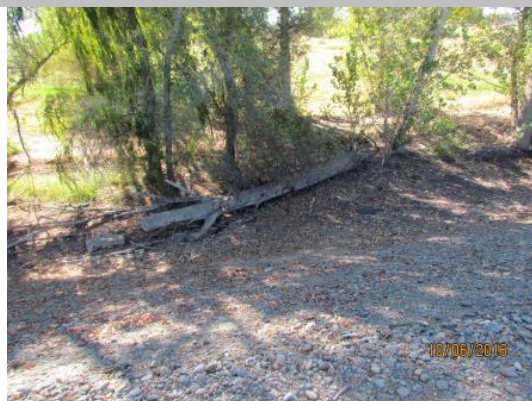
Photo 1 of 1 : FA_2018_MA0013_301_52_20180905_00011.jpg

LM Start	20.65	Rating **	M	Issue No.	52
LM End	20.65	Issue Type +	Ma	Location *	LS
Category	Earthen Levee			GPS Latitude/Longitude	
				Start	End
Item	Encroachments			39.371433 °	39.371433 °
				-121.848753 °	-121.848753 °
DWR ID	DWR_MA0013_02_s_2014_52				
Comment Code					
TR : Tree or limb					
Inspector Comment					
Remove the tree limbs from the landside slope and toe.

View of the tree limbs along the landside toe.

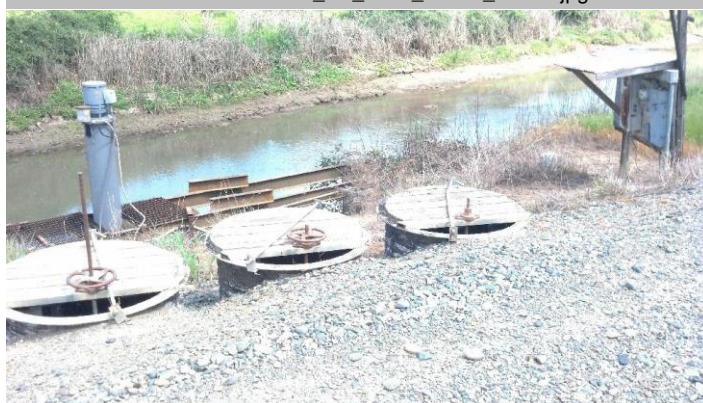
Photo 1 of 3 : UCIP_FA_2018_53320_67406.jpg

Repair Type: Urgent

UCIP Comments: 8/23/2018 The CVFPB has filed an enforcement for this crossing, Enforcement Case: 2018-723. There is still massive erosion around the WS headwall and corrosion and degradation of the LS outlet pipes, so the crossing remains Urgent (D. Sanoski - DWR UCIP).5/30/2017 No repairs have been made here yet. WS still has depressions above the pipe alignment. LS pipe end still showing heavy signs of rusting and deterioration. Sediment build up inside of concrete distribution box on the LS. (DWR Sutter Yard - AFreitag)11/17/2016 Crossing has not been repaired yet. pipe ends still showing heavy signs of rust and corrosion. (DWR Sutter Yard - AFreitag)4/26/2016 No repairs have been made at this crossing yet. (DWR Sutter Yard - AFreitag)6/30/2015 Crossing has not been repaired yet. pipe ends still showing heavy signs of rust and corrosion. (DWR Sutter Yard - AFreitag)5/28/2014 Same as last inspection. (DWR Sutter Yard - afreitag)12/4/2013 Same as last inspection. (DWR Sutter Yard - afreitag)7/8/2013 Same as last inspection. (DWR Sutter Yard - afreitag)4/19/2012 LS pipe collars severely damaged--section missing at flapgate. Buried section of pipe could be in the same condition. Crossing needs to be repaired; will need to coordinate with applicant. WS slide gate handle missing. (DWR UCIP - omagana) FIELD_STRUCT_DESC: 1 of 3: 16-inch steel irrigation pipe encased in reinforced concrete through the levee, 9.7 feet below the crown.

Corrugated metal pipe risers with slide gates located on WS slope.

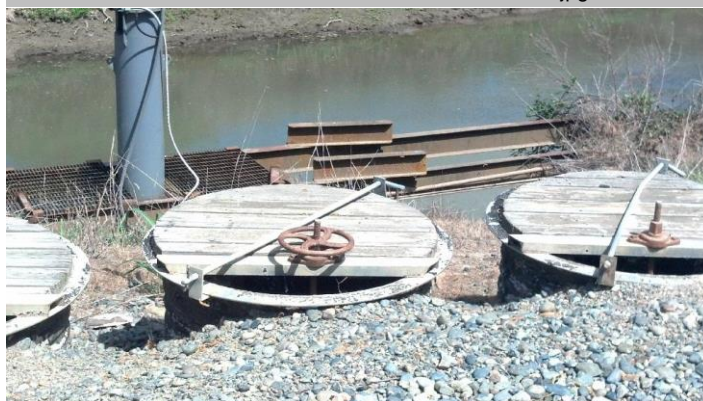
Photo 2 of 3 : UCIP_FA_2018_53321_67418.jpg

UCIP Comments: 8/23/2018 The CVFPB has filed an enforcement for this crossing, Enforcement Case: 2018-723. There is still massive erosion around the WS headwall and corrosion and degradation of the LS outlet pipes, so the crossing remains Urgent (D. Sanoski - DWR UCIP).5/30/2017 No repairs have been made here yet. WS still has depressions above the pipe alignment. LS pipe end still showing heavy signs of rusting and deterioration. Sediment build up inside of concrete distribution box on the LS. (DWR Sutter Yard - AFreitag)11/17/2016 Crossing has not been repaired yet. pipe ends still showing heavy signs of rust and corrosion. (DWR Sutter Yard - AFreitag)4/26/2016 No repairs have been made at this crossing yet. (DWR Sutter Yard - afreitag)6/30/2015 Crossing has not been repaired yet. pipe ends still showing heavy signs of rust and corrosion. (DWR Sutter Yard - afreitag)5/28/2014 Same as last inspection. (DWR Sutter Yard - afreitag)12/4/2013 Same as last inspection. (DWR Sutter Yard - afreitag)7/08/2013 Same as last inspection. (DWR Sutter Yard - afreitag)4/24/2012 LS pipe collars severely damaged--section missing at flapgate. Crossing needs repair. Will need to coordinate with owner. (DWR UCIP - omagana)

Riser for pipe 2 of 3.

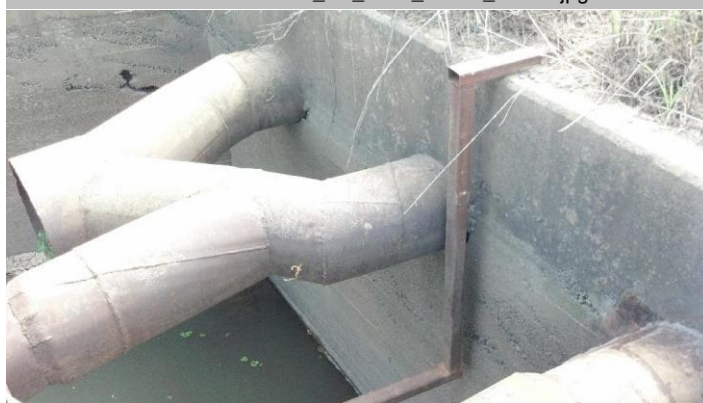
Photo 3 of 3 : UCIP_FA_2018_53321_67415.jpg

FS_ID:53321
DS_ID:17014
EP_NO: N/A
Repair Type: Urgent
Crossing Status: Found
UCIP Comments: 8/23/2018 The CVFPB has filed an enforcement for this crossing, Enforcement Case: 2018-723. There is still massive erosion around the WS headwall and corrosion and degradation of the LS outlet pipes, so the crossing remains Urgent (D. Sanoski - DWR UCIP).5/30/2017 No repairs have been made here yet. WS still has depressions above the pipe alignment. LS pipe end still showing heavy signs of rusting and deterioration. Sediment build up inside of concrete distribution box on the LS. (DWR Sutter Yard - AFreitag)11/17/2016 Crossing has not been repaired yet. pipe ends still shwoing heavy signs of rust and corrosion. (DWR Sutter Yard - AFreitag)4/26/2016 No repairs have been made at this crossing yet. (DWR Sutter Yard - afreitag)6/30/2015 Crossing has not been repaired yet. pipe ends still showing heavy signs of rust and corrosion. (DWR Sutter Yard - afreitag)5/28/2014 Same as last inspection. (DWR Sutter Yard - afreitag)12/4/2013 Same as last inspection. (DWR Sutter Yard - afreitag)7/08/2013 Same as last inspection. (DWR Sutter Yard - afreitag)4/24/2012 LS pipe collars severely damaged--section missing at flapgate. Crossing needs repair. Will need to coordinate with owner. (DWR UCIP - omagana)

FIELD_STRUCT_DESC: 2 of 3: 16-inch steel irrigation pipe encased in reinforced concrete through the levee, 9.7 feet below the crown. Concrete "U" headwall on both ends. Slide gates on corrugated metal pipe risers on the waterside (WS) slope. Pump structure on the WS end. [Additional Reference(s): DWR Levee Log, 1993. USACE Sacramento O&M Manual 519, June 1962 (HLM 21.00)]
FS Date: 8/23/2018 9:50:00 AM

View of pipe 2. Pipe 2 diverts flow to pipe 1.

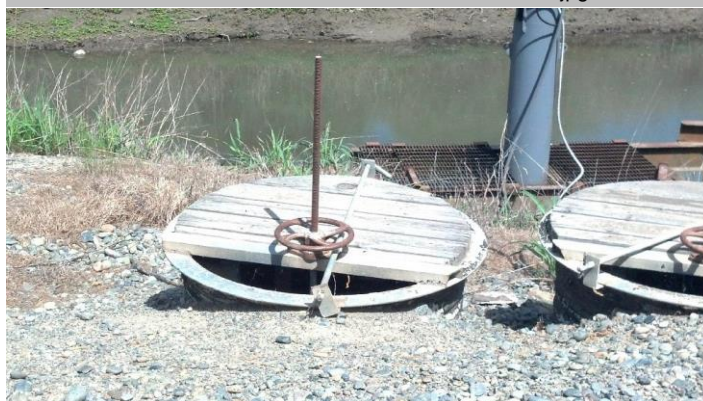
Photo 2 of 3 : UCIP_FA_2018_53322_67443.jpg

UCIP Comments: 8/23/2018 The CVFPB has filed an enforcement for this crossing, Enforcement Case: 2018-723. There is still massive erosion around the WS headwall and corrosion and degradation of the LS outlet pipes, so the crossing remains Urgent (D. Sanoski - DWR UCIP).5/30/2017 No repairs have been made here yet. WS still has depressions above the pipe alignment. LS pipe end still showing heavy signs of rusting and deterioration. Sediment build up inside of concrete distribution box on the LS. (DWR Sutter Yard - AFreitag)11/17/2016 Crossing has not been repaired yet. pipe ends still shwoing heavy signs of rust and corrosion. (DWR Sutter Yard - AFreitag)4/26/2016 No repairs have been made at this crossing yet. (DWR Sutter Yard - afreitag)6/30/2015 Crossing has not been repaired yet. pipe ends still shwoing heavy signs of rust and corrosion. (DWR Sutter Yard - afreitag)5/28/2014 Same as last inspection. (DWR Sutter Yard - afreitag)12/4/2013 Same as last inspection. (DWR Sutter Yard - afreitag)7/08/2013 Same as last inspection. (DWR Sutter Yard - afreitag)4/24/2012 Sink hole present on WS. LS pipe collars severely damaged--section missing at flapgate. Crossing needs repair. Need to coordinate with owner. (DWR UCIP - omagana)

View of corrugated metal pipe for pipe 3 of 3.

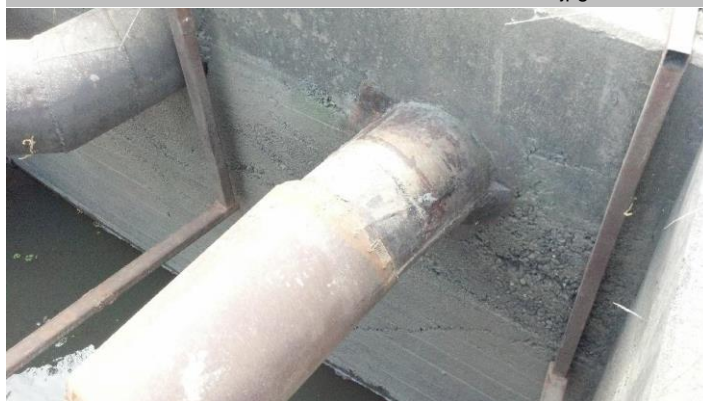
Photo 3 of 3 : UCIP_FA_2018_53322_67442.jpg

UCIP Comments: 8/23/2018 The CVFPB has filed an enforcement for this crossing, Enforcement Case: 2018-723. There is still massive erosion around the WS headwall and corrosion and degradation of the LS outlet pipes, so the crossing remains Urgent (D. Sanoski - DWR UCIP).5/30/2017 No repairs have been made here yet. WS still has depressions above the pipe alignment. LS pipe end still showing heavy signs of rusting and deterioration. Sediment build up inside of concrete distribution box on the LS. (DWR Sutter Yard - AFreitag)11/17/2016 Crossing has not been repaired yet. pipe ends still shwoing heavy signs of rust and corrosion. (DWR Sutter Yard - AFreitag)4/26/2016 No repairs have been made at this crossing yet. (DWR Sutter Yard - afreitag)6/30/2015 Crossing has not been repaired yet. pipe ends still shwoing heavy signs of rust and corrosion. (DWR Sutter Yard - afreitag)5/28/2014 Same as last inspection. (DWR Sutter Yard - afreitag)12/4/2013 Same as last inspection. (DWR Sutter Yard - afreitag)7/08/2013 Same as last inspection. (DWR Sutter Yard - afreitag)4/24/2012 Sink hole present on WS. LS pipe collars severely damaged--section missing at flapgate. Crossing needs repair. Need to coordinate with owner. (DWR UCIP - omagana)

View of Pipe 3 of 3 from WS headwall.

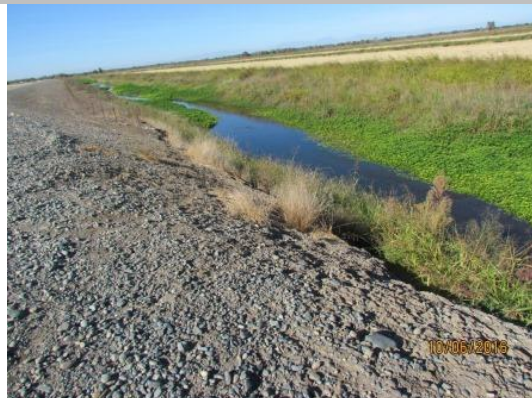
Photo 1 of 1 : FA_2018_MA0013_301_75_20180905_00022.jpg

LM Start	20.77	Rating **	M	Issue No.	75
LM End	20.77	Issue Type +	Ma	Location *	WS
Category	Earthen Levee			GPS Latitude/Longitude	
				Start	End
Item	Erosion / Bank Caving			39.370641 °	39.370641 °
				-121.850572 °	-121.850572 °
DWR ID	DWR_MA0013_02_f_2016_75				
Comment Code					
E1 : Note and monitor erosion site.					
Inspector Comment

View of the erosion along the waterside toe.

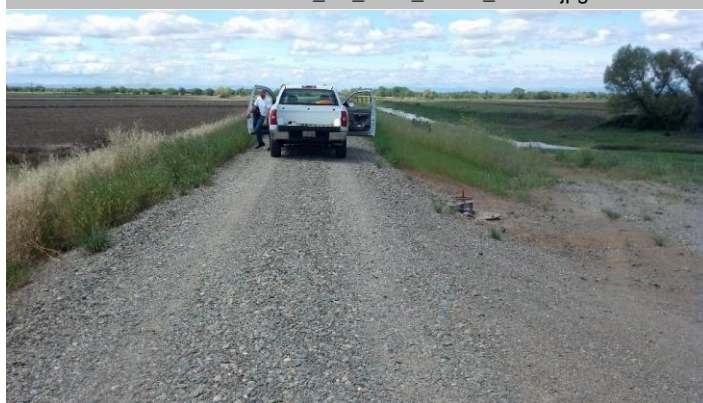
Photo 1 of 3 : UCIP_FA_2018_52168_67447.jpg

FS_ID:52168
DS_ID:16384
EP_NO: N/A
Repair Type: Non-Urgent
Crossing Status: Found
UCIP Comments: 5/30/2017 Crossing appears to be in good condition. Pipe has been selected to be internally cleaned and inspected as part of the DMP project. (DWR Sutter Yard - A Freitag)11/17/2016 Pipe section that crosses through the levee appears to be in good condition. (DWR Sutter Yard - A Freitag)4/26/2016 Pipe appears to have been repaired. Not sure on the extent of the repairs or if they were approved by the Central Valley Flood Control Board.6/30/2015 Pipe is currently undergoing repairs. Not sure what all is planed to be fixed but will update the photos and inspection report with new details when its completed.5/28/2014 Same as last inspection.12/4/2013 Same as last inspection.7/08/2013 Pipe appears to have been repaired. Need to talk to inspections and supervisor to find out more deatils on repair.4/24/2012 Needs repair. Internal piping, severe corrosion. Debris present--rusted pipe stockpiled on LS slope. Limited inspection on WS and LS slopes due to dense vegetation. Need photos of cleared WS & LS slopes. This crossing was listed in the USACE Periodic Inspection report as Corp's inspect ID# USACE_CESPK_M13E_2011_p_0234 for no WS gate but sluice gate present.

FIELD_STRUCT_DESC: 24-inch corrugated metal drainage pipe through the levee, 8.2 feet below the crown. Crossing penetrates levee at angle. Slide gate in corrugated metal pipe (CMP) riser on the waterside (WS) slope. Pipe crosses the channel. Corroded section of existing pipe, 9-foot and 8-inch of an 18-inch corrugated metal pipe section, was replaced under Permit 7231 prior to 1974. (Permit No. 7231, 1960 - Estate of Walter L. King) [Additional Reference(s): DWR Levee Log, 1993. USACE Sacramento O&M Manual 519, June 1962 (HLM 21.60)]
FS Date: 6/8/2017 10:33:29 AM

Overview of crossing looking downstream.

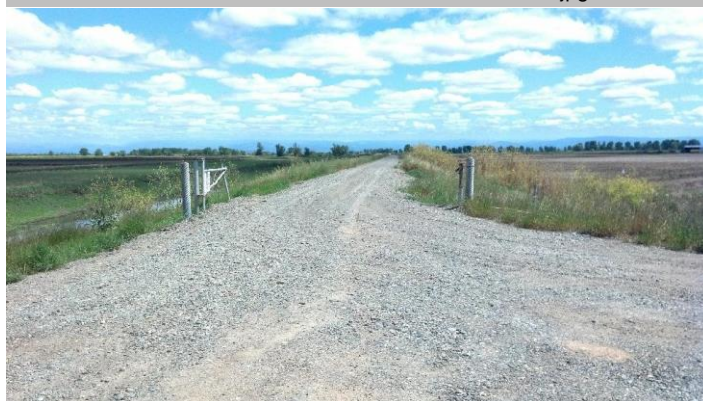
Photo 1 of 3 : UCIP_FA_2018_52170_67462.jpg

Comment Code					
Inspector Comment					
FS_ID:52170 DS_ID:16394 EP_NO: N/A Repair Type: Non-Urgent Crossing Status: Found UCIP Comments: 5/30/2017 WS flap gate showing signs of rusting and deterioration but still appears to be able to function properly. Pipe has been selected to be internally cleaned and inspected as part of the DMP project. (DWR Sutter Yard - A Freitag)11/17/2016 WS flap gate is really rusted and deteriorated but it appears to still function properly. (DWR Sutter Yard - A Freitag)4/26/2016 WS flap gate is really rusted and deteriorated. May need to be replaced. The rest of the crossing appeared in good condition.6/30/2015 Crossing is in good condition. No noticeable issues to be reported.5/28/2014 Same as last inspection.12/4/2013 WS ans LS slopes are in good condition.7/08/2013 Same as last inpection.4/24/2012 Limited inspection on WS and LS slopes due to dense vegetation. Need photos of cleared WS and LS slopes. This crossing was listed in the USACE Periodic Inspection report as Corp's inspect ID# USACE_CESPK_M13E_2011_p_0251 for no outlet visible on WS. FIELD_STRUCT_DESC: 24-inch corrugated metal drainage pipe through the levee, 11.6 feet below the crown. Flap gate on the waterside (WS) end. Concrete "U" headwalls on both WS and landside (LS). Rusted gate located on the WS (gate stuck). [Additional Reference(s): DWR Levee Log, 1993. USACE Sacramento O&M Manual 519, June 1962 (HLM 22.08)] FS Date: 6/8/2017 10:37:02 AM

Overview of crossing looking upstream at the left bank of Cherokee Canal.

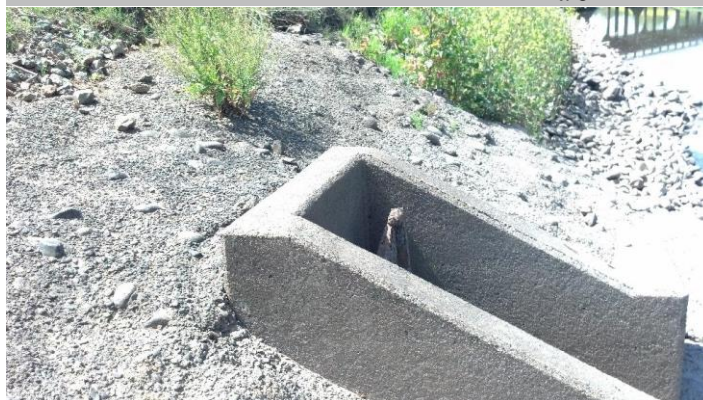
Photo 2 of 3 : UCIP_FA_2018_52170_67460.jpg

View of WS headwall.

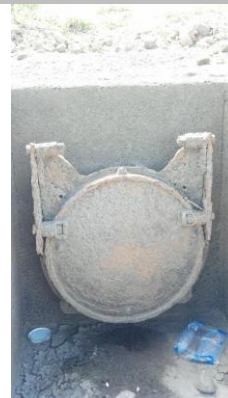
Photo 3 of 3 : UCIP_FA_2018_52170_67461.jpg

Item	DWR UCIP LMA Responsibility			39.362378 °	39.362378 °	
				-121.867350 °	-121.867350 °	
DWR ID	16394					
Comment Code						
Inspector Comment						
FS_ID:52170 DS_ID:16394 EP_NO: N/A Repair Type: Non-Urgent Crossing Status: Found UCIP Comments: 5/30/2017 WS flap gate showing signs of rusting and deterioration but still appears to be able to function properly. Pipe has been selected to be internally cleaned and inspected as part of the DMP project. (DWR Sutter Yard - A Freitag) 11/17/2016 WS flap gate is really rusted and deteriorated but it appears to still function properly. (DWR Sutter Yard - A Freitag) 4/26/2016 WS flap gate is really rusted and deteriorated. May need to be replaced. The rest of the crossing appeared in good condition. 6/30/2015 Crossing is in good condition. No noticeable issues to be reported. 5/28/2014 Same as last inspection. 12/4/2013 WS and LS slopes are in good condition. 7/08/2013 Same as last inspection. 4/24/2012 Limited inspection on WS and LS slopes due to dense vegetation. Need photos of cleared WS and LS slopes. This crossing was listed in the USACE Periodic Inspection report as Corp's inspect ID# USACE_CESPK_M13E_2011_p_0251 for no outlet visible on WS. FIELD_STRUCT_DESC: 24-inch corrugated metal drainage pipe through the levee, 11.6 feet below the crown. Flap gate on the waterside (WS) end. Concrete "U" headwalls on both WS and landside (LS). Rusted gate located on the WS (gate stuck). [Additional Reference(s): DWR Levee Log, 1993. USACE Sacramento O&M Manual 519, June 1962 (HLM 22.08)] FS Date: 6/8/2017 10:37:02 AM

Flap gate located on WS.

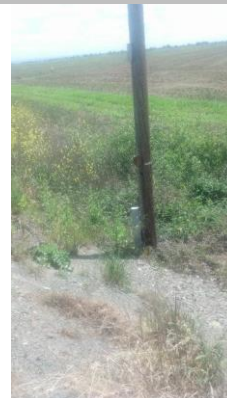
Photo 1 of 1 : UCIP_FA_2018_52172_67480.jpg

Comment Code					
Inspector Comment					
FS_ID:52172 DS_ID:16374 EP_NO: N/A Repair Type: Non-Urgent Crossing Status: Indicator Found UCIP Comments: 5/30/2017 Splice box still present at LS toe. (DWR Sutter Yard - A Freitag)11/17/2016 Splice box still present at LS toe. (DWR Sutter Yard - A Freitag)4/26/2016 Communication Splice box was still present. Not sure what was done to ever resolve the encroachment issue.6/30/2015 Same as last inspection.5/28/2014 Same as last inspection.12/4/2013 Same as last inspection.7/08/2013 Same as last inspection.4/24/2012 Unauthorized Encroachment. This crossing is listed multiple times in the USACE Periodic Inspection report as USACE_CESPK_M13E_2011_p_0307, 0315, 0317, 0318 for slope failure on LS hinge. DWR-Flood Maintenance Office records shows that CVFPB has requested AT&T to remove conduit in June 2, 2009 letter. LMA working with CVFPB to resolve. FIELD_STRUCT_DESC: *ILLEGAL ENCROACHMENT* Underground telephone cable through the levee. Depth unknown. (AT&T) START latitude 39.36210336, longitude -121.8678207 END latitude 39.35458541, longitude -121.8823409. Line extends from Gridley Colusa Highway to the south end of project levee along landside (LS) shoulder and levee crown hinge point. Levee sloughs along cable trench after heavy rains. [Additional Reference(s): DWR Levee Log, 1993] FS Date: 6/8/2017 10:39:36 AM

View of utility line located on LS toe.

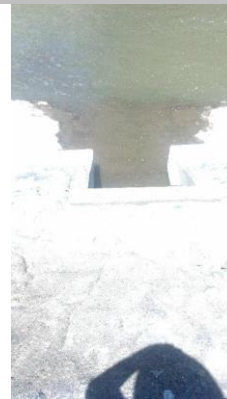
Photo 2 of 3 : UCIP_FA_2018_52175_67496.jpg

Comment Code						
Inspector Comment						
FS_ID:52175 DS_ID:16391 EP_NO: N/A Repair Type: Non-Urgent Crossing Status: Found UCIP Comments: 5/30/2017 Location of LS inlet still unknown. Need to trace with utility locator/GPR to find. Pipe has been selected to be internally cleaned and inspected as part of the DMP project. (DWR Sutter Yard - A Freitag)11/17/2016 Unable to locate LS pipe end. Ws appears to be in good condition. (DWR Sutter Yard - A Freitag)4/26/2016 Still unable to locate the LS headwall and end of pipe. Pipe is still being used. Pipe was draining to WS.6/30/2015 Still unable to locate the LS headwall and pipe end.5/28/2014 Same as last inspection.12/4/2013 Same as last inspection.7/08/2013 Same as last inspection. Unable to locate LS headwall.4/24/2012 Unable to locate LS headwall. Need photo of LS headwall during next inspection. FIELD_STRUCT_DESC: 30-inch corrugated metal drainage pipe through the levee, 15.3 feet below the crown. Concrete "U" headwalls on both waterside (WS) and landside (LS) ends. Flap gate on the WS end. This pipe runs on an angle through the levee, then underground along the LS slope to historic levee mile (HLM) 22.39 where it enters a ditch on the LS. [Additional Reference(s): DWR Levee Log, 1993. USACE Sacramento O&M Manual 519, June 1962 (HLM 22.41)] FS Date: 6/8/2017 10:42:36 AM

View of WS slope looking from WS headwall to levee crown.

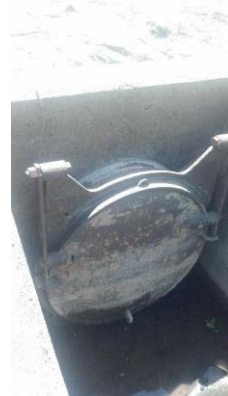
Photo 3 of 3 : UCIP_FA_2018_52175_67497.jpg

Item	DWR UCIP LMA Responsibility			39.359827 °	39.359827 °	
				-121.872300 °	-121.872300 °	
DWR ID	16391					
Comment Code						
Inspector Comment						
FS_ID:52175 DS_ID:16391 EP_NO: N/A Repair Type: Non-Urgent Crossing Status: Found UCIP Comments: 5/30/2017 Location of LS inlet still unknown. Need to trace with utility locator/GPR to find. Pipe has been selected to be internally cleaned and inspected as part of the DMP project. (DWR Sutter Yard - A Freitag)11/17/2016 Unable to locate LS pipe end. Ws appears to be in good condition. (DWR Sutter Yard - A Freitag)4/26/2016 Still unable to locate the LS headwall and end of pipe. Pipe is still being used. Pipe was draining to WS.6/30/2015 Still unable to locate the LS headwall and pipe end.5/28/2014 Same as last inspection.12/4/2013 Same as last inspection.7/08/2013 Same as last inspection. Unable to locate LS headwall.4/24/2012 Unable to locate LS headwall. Need photo of LS headwall during next inspection. FIELD_STRUCT_DESC: 30-inch corrugated metal drainage pipe through the levee, 15.3 feet below the crown. Concrete "U" headwalls on both waterside (WS) and landside (LS) ends. Flap gate on the WS end. This pipe runs on an angle through the levee, then underground along the LS slope to historic levee mile (HLM) 22.39 where it enters a ditch on the LS. [Additional Reference(s): DWR Levee Log, 1993. USACE Sacramento O&M Manual 519, June 1962 (HLM 22.41)] FS Date: 6/8/2017 10:42:36 AM

View of flap gate on WS.

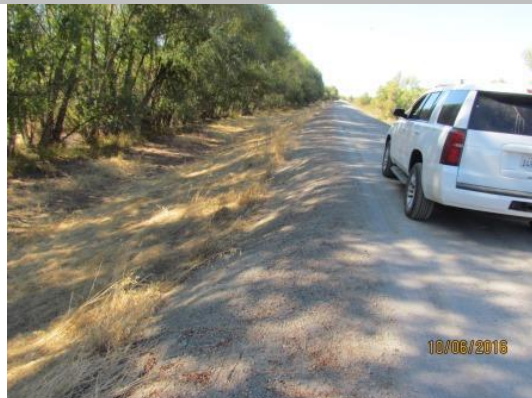
Photo 1 of 1 : FA_2018_MA0013_301_62_20180905_00014.jpg

LM Start	22.33	Rating **	A/W	Issue No.	62
LM End	22.33	Issue Type +	Ma	Location *	LS
Category	Earthen Levee			GPS Latitude/Longitude	
				Start	End
Item	Slope Stability			39.358419 °	39.358419 °
				-121.875088 °	-121.875088 °
DWR ID	DWR_MA0013_02_s_2016_62				
Comment Code					
S1 : Repair slope instability.					
Inspector Comment

View of slope instability issue along the landside slope.
